UPPER MOHAWK LAKE DAM NJ 00292

PHASE 1 INSPECTION REPORT
NATIONAL DAM SAFETY PROGRAM

JULY 1981

National Dam Safety Program. Upper
Mohawk Lake Dam (NJ00292), Delaware
River Basin, Tributary to Paulins Kill
River, Sussex County, New Jersey. Phase
I Inspection Report.

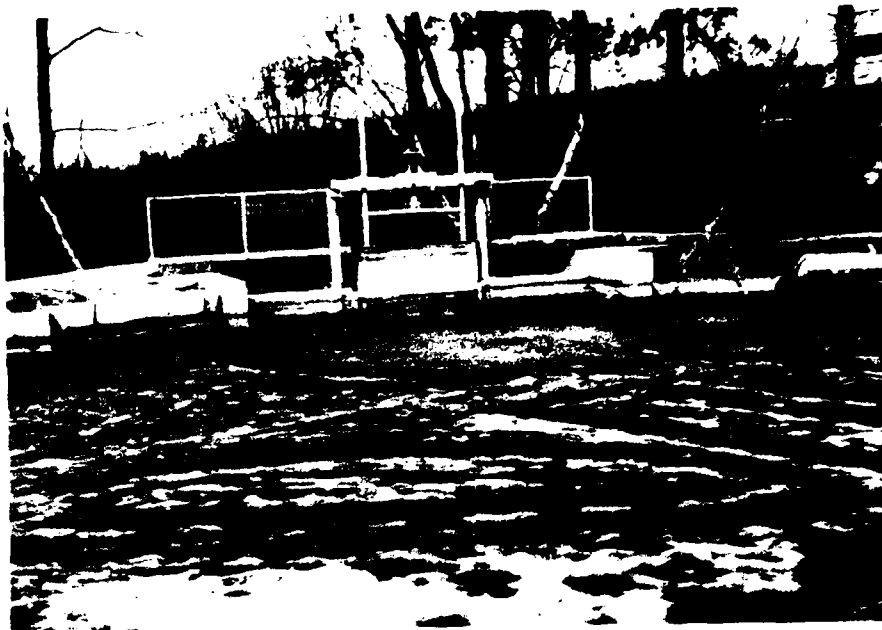
PHOTO 1
UPSTREAM VIEW OF SPILLWAY

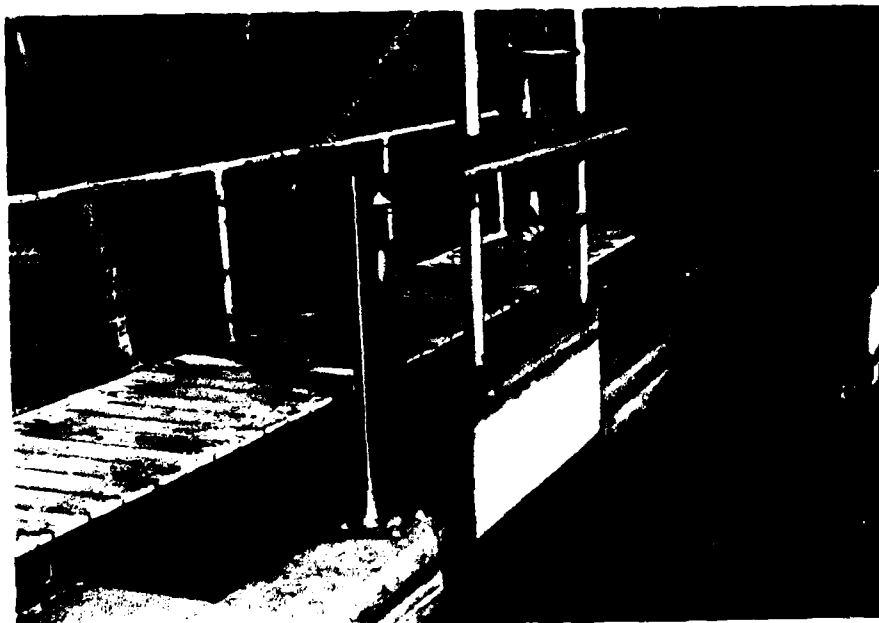
PHOTO 2
SPILLWAY WEIR AND GATE

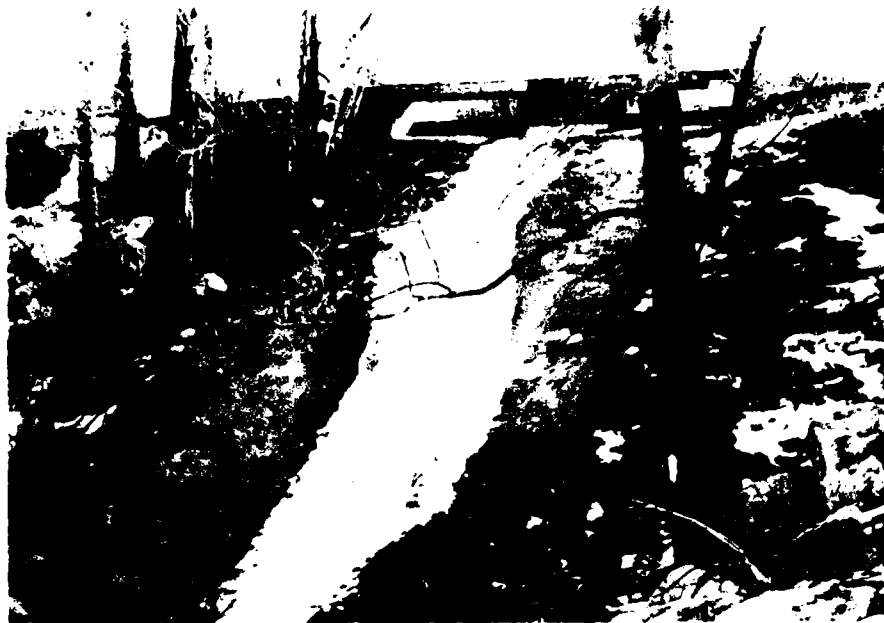
The spillway consisted of a notched concrete weir. The downstream side of the spillway consisted of a fairly roughly poured concrete flume on the downstream side of the dam. At the downstream end of the flume the entrance to a reinforced concrete pipe was observed. The pipe ran under a parking area which was under construction. It then ran under Newton-Sparta Road and emerged on the other side. The concrete surfaces forming the spillway crest and abutments appeared to be in satisfactory condition. A few cracks were observed in the concrete forming the downstream flume although it appeared to be generally stable and in satisfactory condition. There was a timber slide gate at the notch in the center of the concrete weir. The gate together with its steel frame and lifting mechanism appeared to be in satisfactory condition. The steel frame and lifting mechanism appeared to be adequately protected by paint. There was a timber walkway across the spillway and it appeared to be in fair condition. A pipe railing on the downstream side of the walkway was in satisfactory condition. The entrance to the pipe below the spillway had a trash rack formed by six pipes embedded in the concrete. The pipes appeared to be new but they did not appear to be well embedded and could be loosened easily. There was no headwall at the entrance to the pipe but rather a flared end section. The slope around the entrance to the pipe was stabilized by large boulders which appeared to be well placed. The stabilization appeared to be satisfactory.

PHOTO 3
SPILLWAY DISCHARGE FLUME
